Main gear leg sockets MG03P/S

Applicability: Components delivered between the beginning of December 2000 and the end of May 2001.

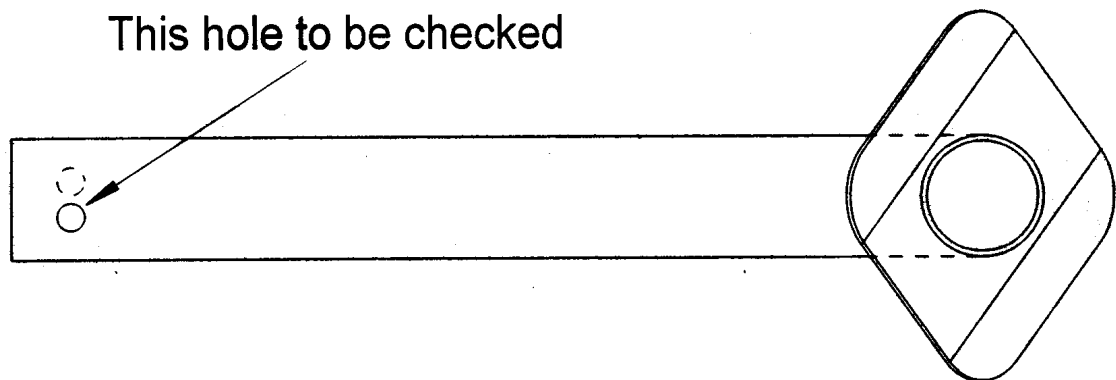
It has been established that a batch of components of the above part number included some which had the hole at the top drilled incorrectly, such that it did not line up with the equivalent hole in the main gear leg. Figure 1 shows a view of the socket and the hole concerned.

Fig 1. Main gear leg socket showing mounting hole.

1. Trial fit the main gear legs to the sockets to establish whether the AN5-21A bolt will pass through both components.
2. If the components are defective, return them to Europa for free replacement.
